Dynamic assessment of a FRP suspension footbridge through field testing and finite element modelling

Votsis, R, Stratford, T & Chryssanthopoulos, M 2017, 'Dynamic assessment of a FRP suspension footbridge through field testing and finite element modelling', *Steel and Composite Structures*, vol. 23, no. 2, pp. 205-215. <https://doi.org/10.12989/scs.2017.23.2.205>

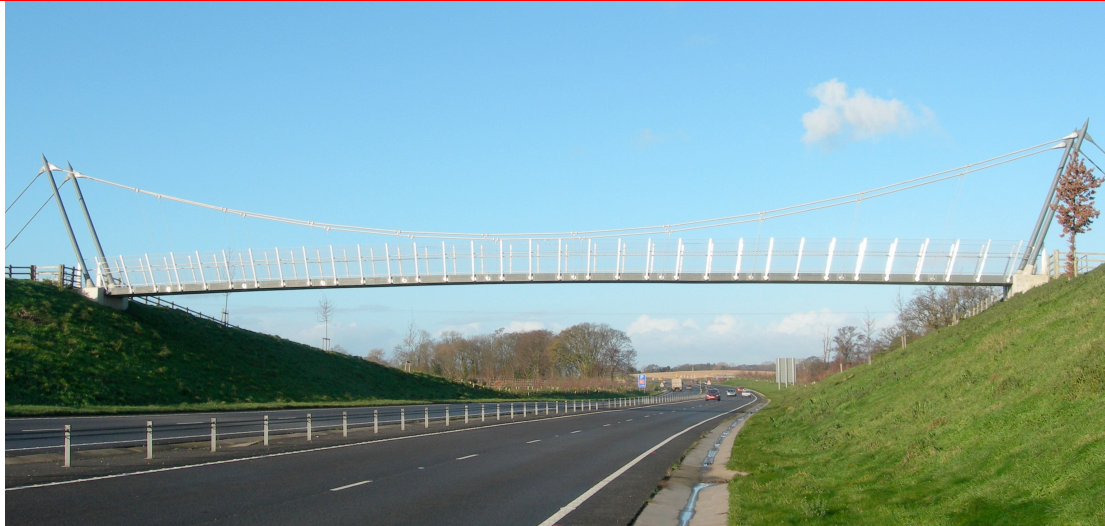
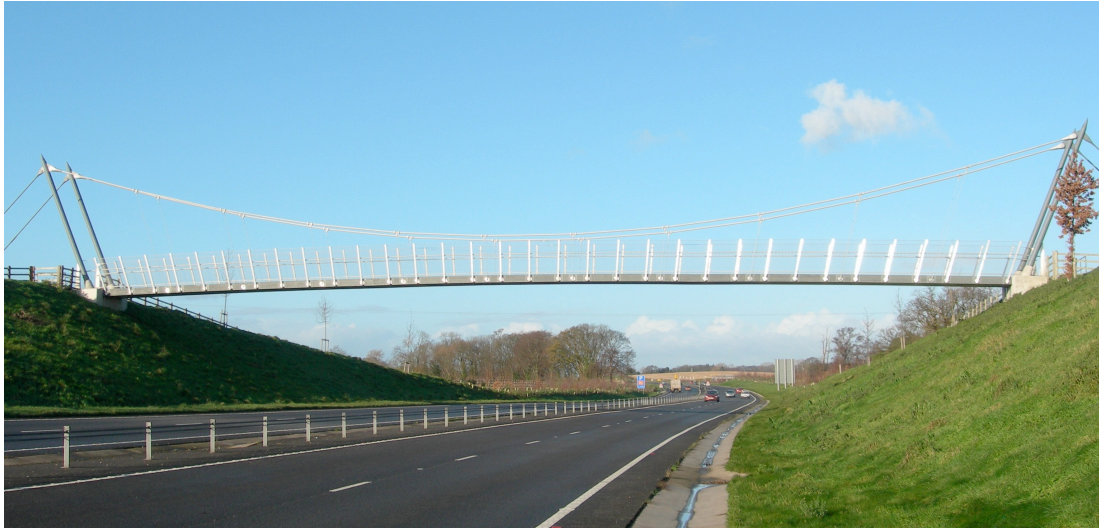
Fig. 1 An overview of the completed Wilcott footbridge.

Fig. 1. An overview of the completed Wilcott footbridge.

The Wilcott footbridge is located in Shropshire, UK and was opened in March 2003. It connects the villages of Wilcott and Nesscliffe, which are separated by the A5 dual carriageway road. It is a 51.3m single span suspension footbridge with a slightly cambered 2m wide deck (Cadei 2003). A general view of the bridge can be seen in Fig. 1.

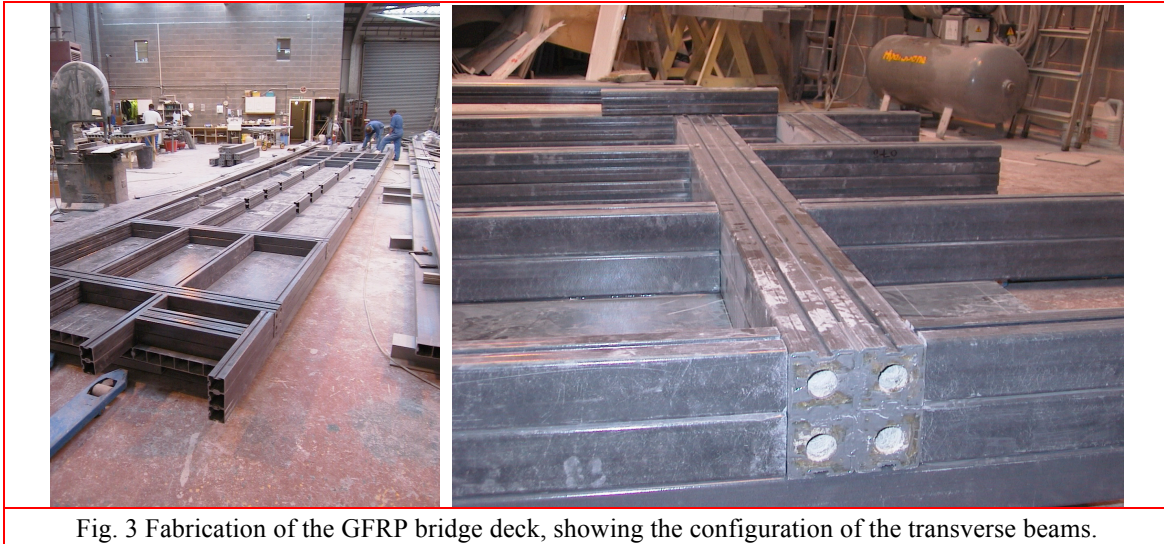
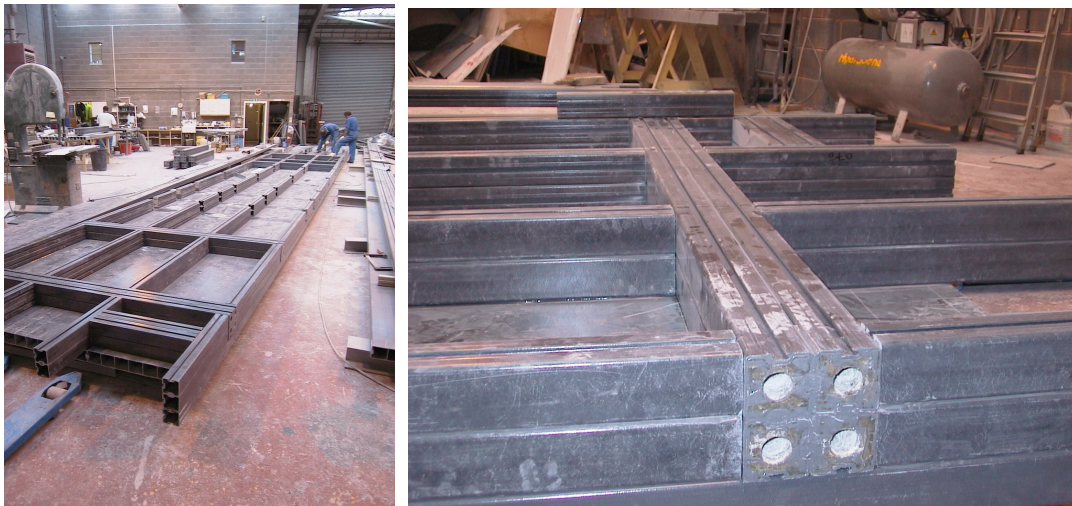
Fig. 3 Fabrication of the GFRP bridge deck, showing the configuration of the transverse beams.

Fig. 3. Fabrication of the GFRP bridge deck, showing the configuration of the transverse beams.

The main feature of the bridge is the glass fibre reinforced polymer (GFRP) deck. It was fabricated from the Advanced Composite Construction System (ACCS) which is pultruded by Strongwell Corp under the trade name Composolite (Strongwell 2010). The same system was previously used on the Aberfeldy footbridge, a 63m span cable-stayed bridge constructed in 1992 (Stratford 2012). The ACCS is a modular system comprising standard pultruded components that are connected together by adhesive bonding, with a mechanical interlock “toggle” connection that provides location and support whilst the adhesive cures. The Wilcott footbridge deck is shown in Fig. 2, and Fig. 3 shows part of the deck during fabrication (before closing the box). The transverse cross-beams visible in Fig. 3 are located where the hanger cables are connected to the bridge deck, as well as at every parapet post (see Fig. 1). The GFRP deck was prefabricated in three equal parts which were later assembled on-site. It is topped by interlocking rubber blocks manufactured from recycled vehicle tyres.

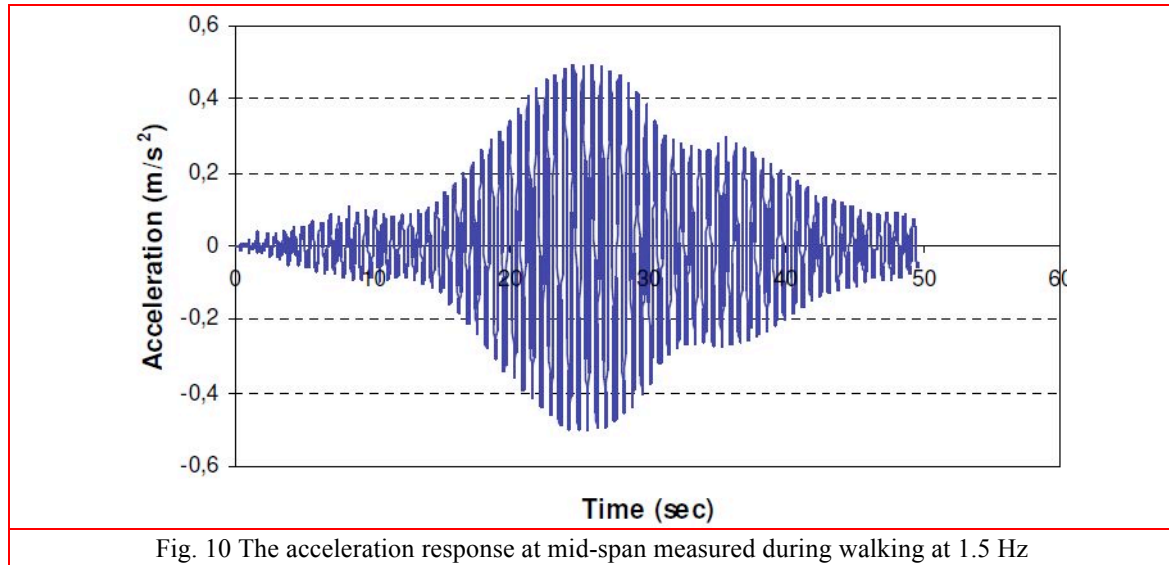
Fig. 10 The acceleration response at mid-span measured during walking at 1.5 Hz

the time-history response for walking at 1.5Hz is shown in Fig. 10, recorded at mid-span. The acceleration response increases until it reaches a maximum when the pedestrian reaches the centre of the bridge (the antinode of mode V2, see Fig. 8). The acceleration drops when the pedestrian approaches the modal nodes and diminishes when the pedestrian leaves the bridge deck at 49s.
